Immediate UAV-enabled Infrastructure Reconnaissance following Recent Natural Disasters: Case Histories from Greece

D. Zekkos¹

J. Manousakis

W. Greenwood, J. D. Lynch

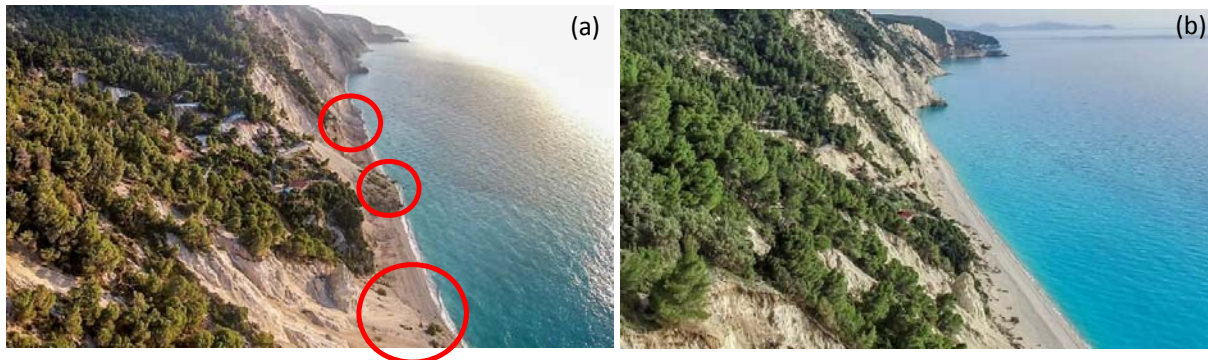
Figure 1. View of landsliding in Egremnoi beach in the island of Lefkada (a) 2 days; (b) 5 months after the November 17th 2015 earthquake. The evolution of landslide geometry within this period of time is evident.

Due to the extensive landsliding, the road network was heavily damaged and many of the coastal areas became inaccessible to the public as well as disaster inspection crews. Among the affected areas is the Egremnoi Beach, where 200-m in height landslides were triggered. To facilitate an assessment of the affected area, a UAV was launched to collect optical imagery. Fig. 1a is a frame extracted from the UAV footage that showcases a side view of the Egremnoi beach just two days after the earthquake. The landsliding disturbance is extensive and

the debris cones from the landslides have covered large parts of the beach. Note that the footage collected by the UAV was placed on Youtube and generated significant public interest (was viewed by ~6,000 viewers within a week), because it provided an overview of the landslides that was not previously available. Fig. 1b is a view of the same area on April 12th 2016, i.e., nearly five months after the earthquake event. The differences between the two photos is evident and highlight the importance of timely collection of perishable data; the landslide debris cones are already nearly washed away by wave action.

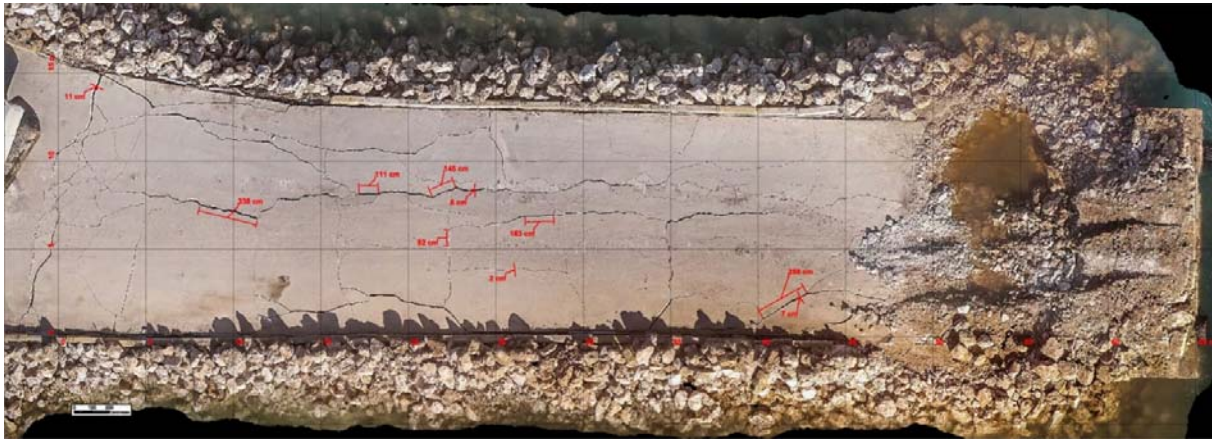
A 12 m wide, 73 m long newly constructed port pier in the port of Vasiliki was damaged during the November 17th 2015 earthquake in Lefkada island. A recording station in the town of Vasiliki recorded a Peak Ground Acceleration of 0.36g (North component). The port pier settled, and as a result, its paved surface cracked extensively. The UAV was deployed and executed a flight at an approximate height of 5 m above the pier for 7 minutes. The developed 3D model, shown in Fig. 2 as an orthophoto, has a ground sampling distance of 0.5 cm/pixel. The dimensions of the cracks can be measured directly from the model and generally were found to vary in opening from mm size up to 11 cm.

Figure 2. Orthophoto of the damaged port pier in the town of Vasiliki in Lefkada island.

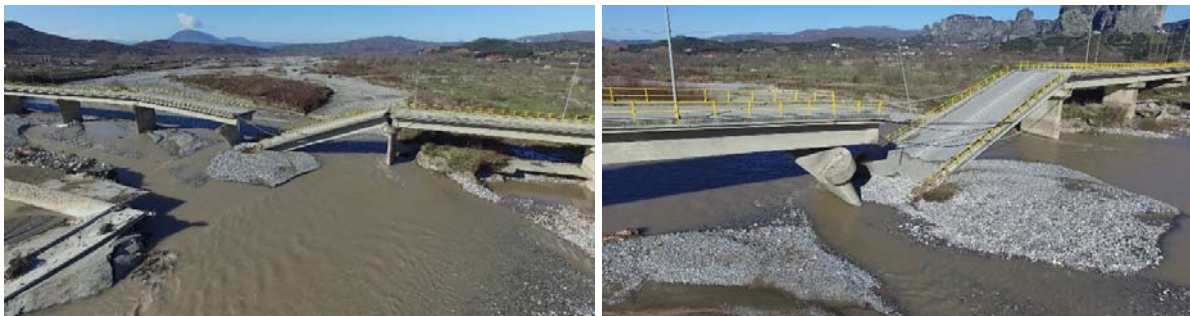
Diavas bridge is a segmented, simply supported, bridge deck on piers type bridge that connects the town of Kalampaka with a number of villages. It is 200 m in length and has an average height of about 6.5 m. It was built in 1982. Since then, natural erosion, as well as illegal aggregate excavation was observed and was postulated to be a threat to its piers. On January 16th 2016, at 10:00 am, following several days of significant precipitation, one of its piers translated, rotated, and tilted, resulting in a collapse of one of the simply supported decks, as shown in Fig. 3. The bridge was closed and became inaccessible to the public.

Figure 3. Oblique view of Diavas bridge from a distance and a closer view of the scoured bridge pier.

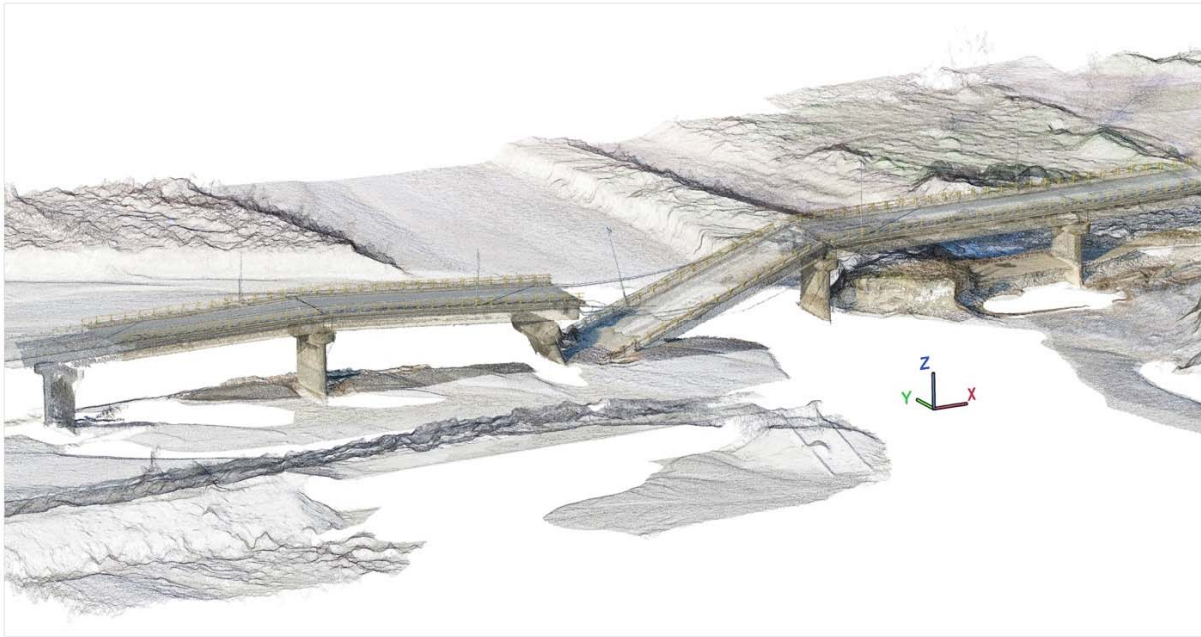
Figure 4. 3D point cloud of Diavas Bridge.

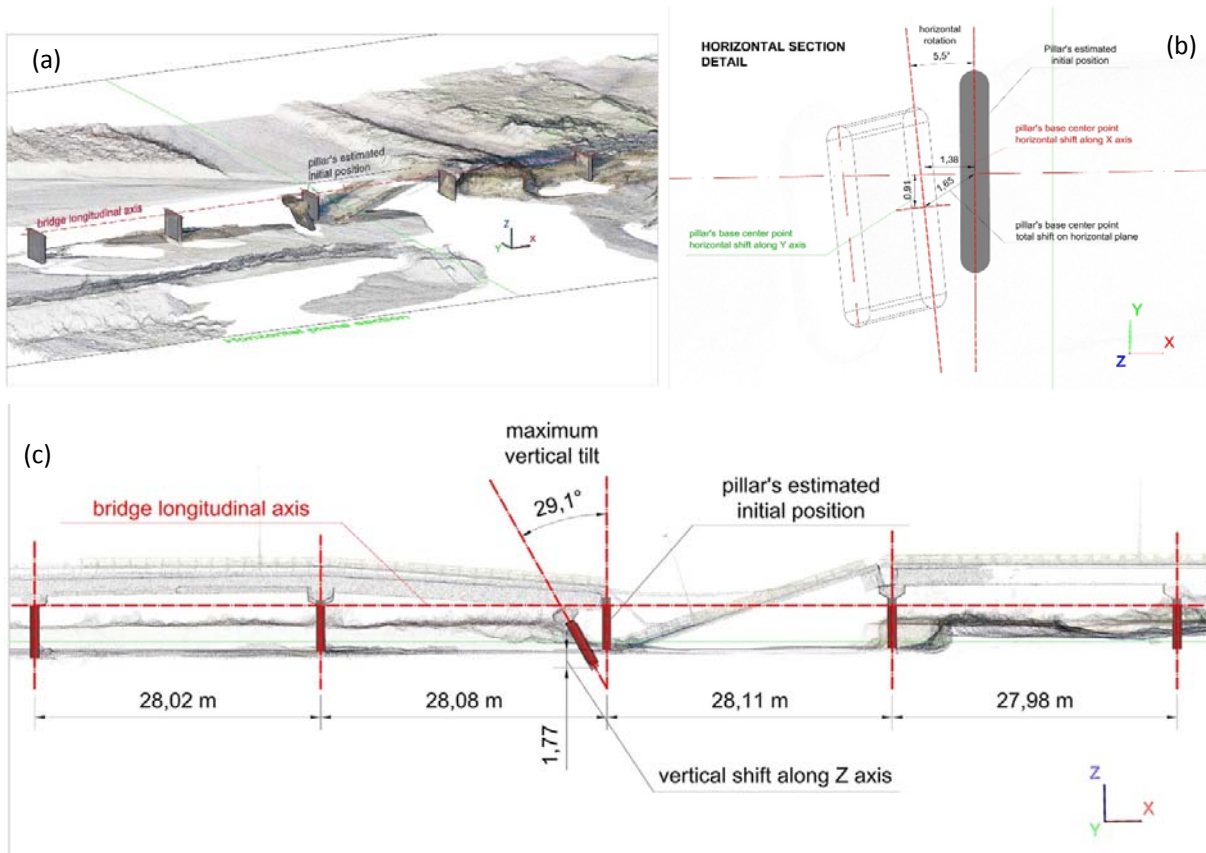
Figure 5. Cross-sections through the 3D point cloud model of Diavas Bridge: (a) horizontal, longitudinal section through the bridge; (b) horizontal section through the displaced bridge pier; and (c) vertical, longitudinal section through the bridge.

model was developed using 649 photos from different locations and with different camera perspectives. The ground sampling distance is 0.5 cm/pixel and the relative error in the model in the failure area is estimated to be less than one cm. An overview of the 3D model of the bridge is shown in Fig. 4. Fig. 5a is a horizontal section through the model that essentially digitally removes the bridge deck and allows a 3D view of the bridge below the deck. The original position of the pier is also shown on this Figure. Fig. 5b is a horizontal cross-section through the displaced and rotated bridge pier. Fig 5c is a longitudinal vertical cross-section through the bridge. As evident in the cross-sections, accurate measurements of the pier's final position can be estimated from the 3D model. Overall, the bridge pier displaced 1.38 m along the bridge axis, 0.91 m perpendicular to its axis, and was subjected to a horizontal rotation of 5.7°, and a vertical inclination of 29.1°. The vertical displacement was measured at 1.77 m compared to the original position of the pier.

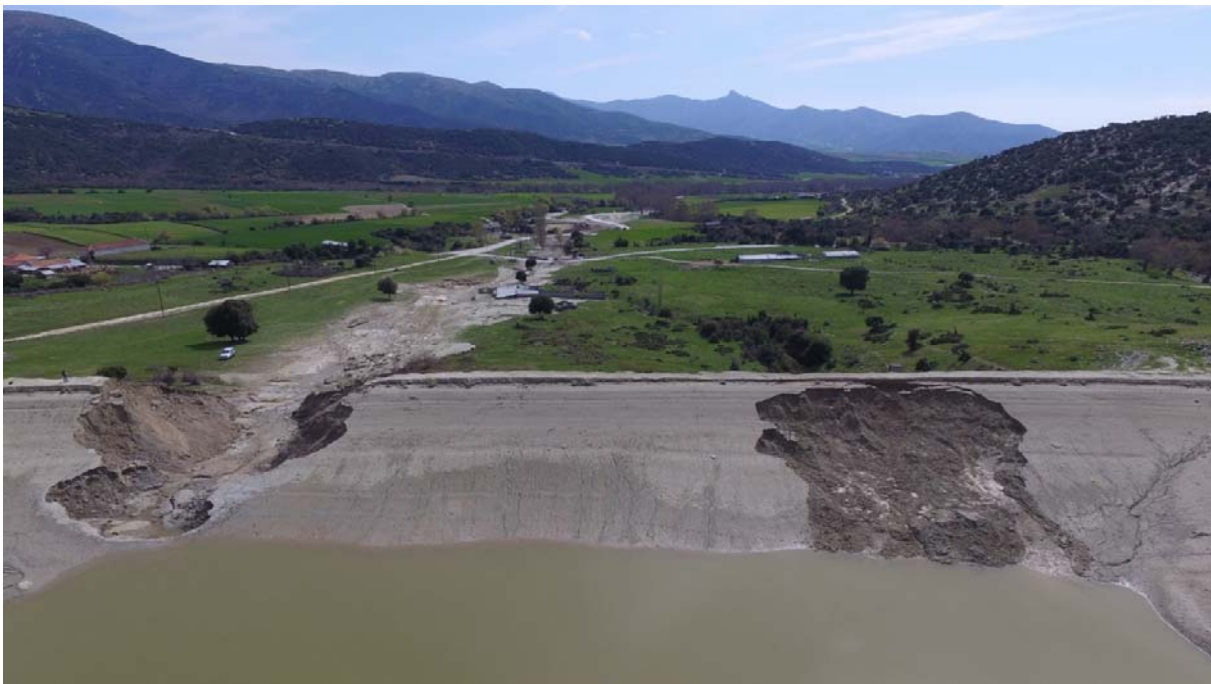
Sparmos dam is a uniform earthfill dam constructed in the late 1980s for irrigation purposes near the town of Elassona in Greece. On March 26th 2016, the dam collapsed resulting, per our own calculations using the 3D model developed, in the release of 80,000 m³ of stored water downstream. Fig 6 is a view of the collapsed section of the dam along with the downstream impacted area. Reportedly, a 5 m wave initiated from the dam and scoured the ground surface immediately downstream, as well as caused flooding downstream to a length of 1 km, at which point the floodwaters reached a natural ravine and stream.

The dam failure was originally attributed to overtopping. Field observations just two days after the failure clearly indicated that the dam was never overtopped, since the existing spillway was completely dry. Instead, the UAV geometry revealed that the intact portion of the downstream slope of the dam, that is supposed to be generally dry, was wet, heavily deformed, with numerous localized failures, evidence of piping, soil washing and erosion. The dam probably suffered some additional localized failure or additional piping that led to a collapse of that section of the dam and subsequent wash-out of the failed section. Fig. 7a is an orthophoto of the dam and Fig. 7b is an oblique view of the 3D model. The location of the failure is also illustrated. Also, in Fig. 7a the disturbance of the downstream side of the dam is evident. Fig. 7 also illustrates a secondary rapid draw-down failure, which testimonies confirmed that it occurred during the abrupt emptying of the stored water. Fig. 8 shows cross-sections through the two failure areas of the dam that can be used for an assessment of the failure as well as stability analyses.

Figure 6. Aerial view of the Sparmos Dam failure.

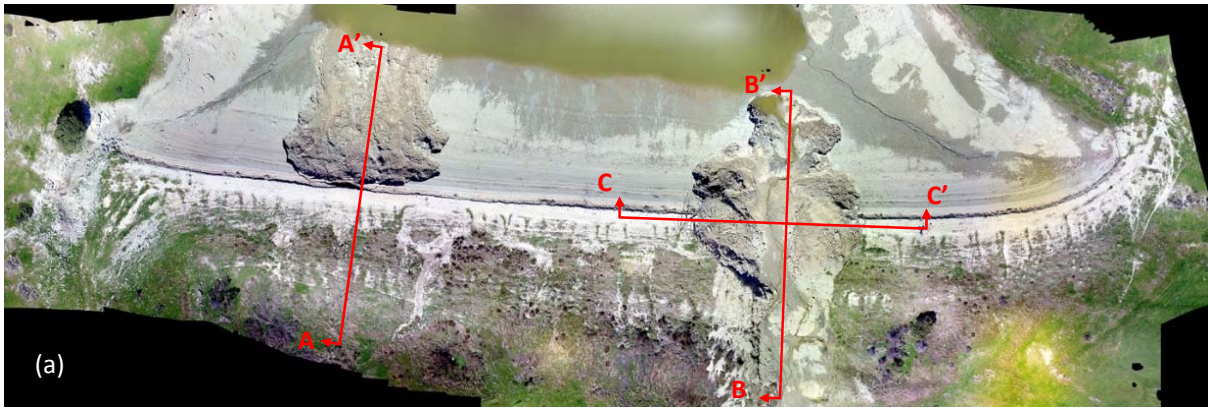
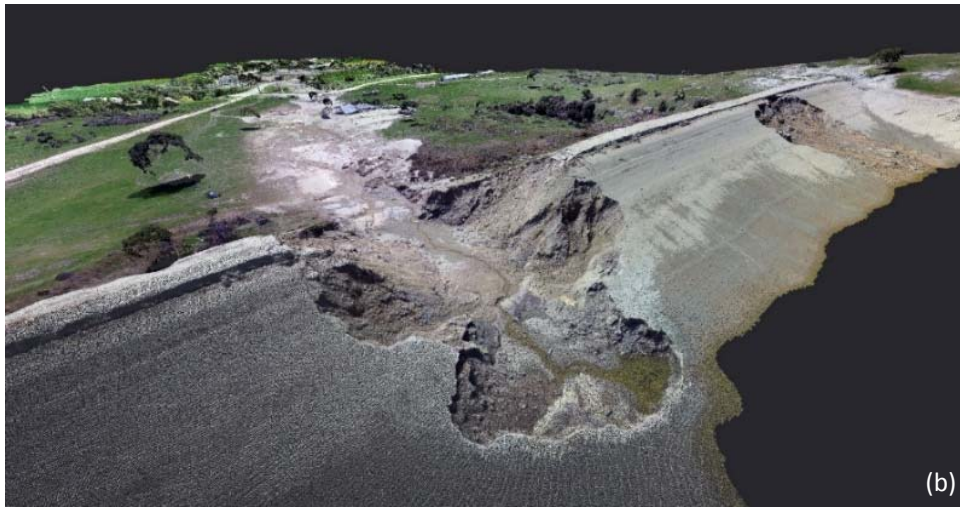
Figure 7. UAV-enabled 3D model of Sparmos Dam failure in Greece. (a) Orthophoto (plan view) illustrating also the disturbance in the downstream side of the dam (lower side in the picture); (b) 3D point cloud/model of the dam.

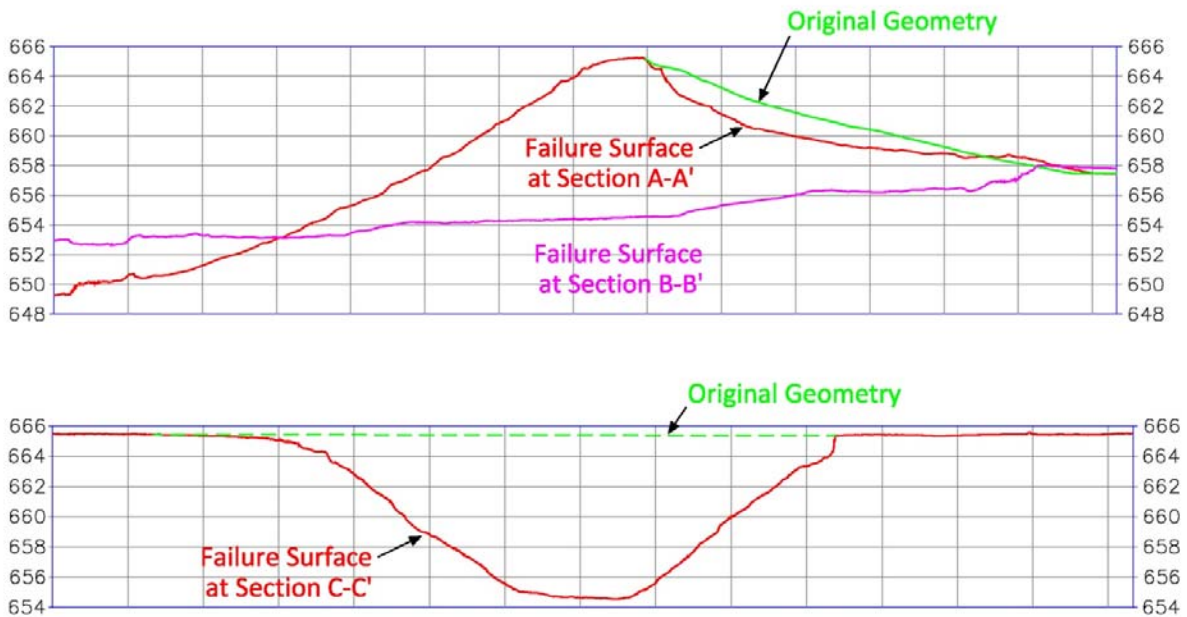
Figure 8. Cross-sections through the failure areas of Sparmos Dam (1:1 horizontal to vertical scale).

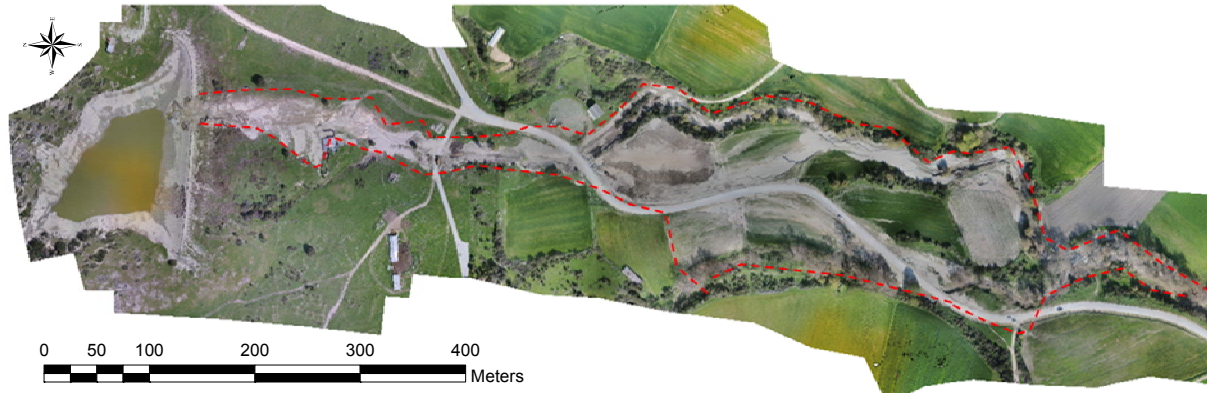
Figure 9 is an orthophoto of the affected area that includes the dam, the reservoir area, and the downstream area that was flooded. The delineated area illustrates the path of water as it flooded the downstream areas. This model was georeferenced and scaled using RTK GPS. A total of 12 GPS points were used for model scaling and 6 GPS points for model error assessment. The Total Mean Error of the model is estimated at ± 2.5 cm for an area equal to 310,000 m².

Figure 9. Orthophoto of Sparmos Dam failure and downstream flooded area.
