Analysis of slope instabilities in the Corinth Canal using UAV-enabled mapping

C. Saroglou¹, V. Kallimogiannis¹

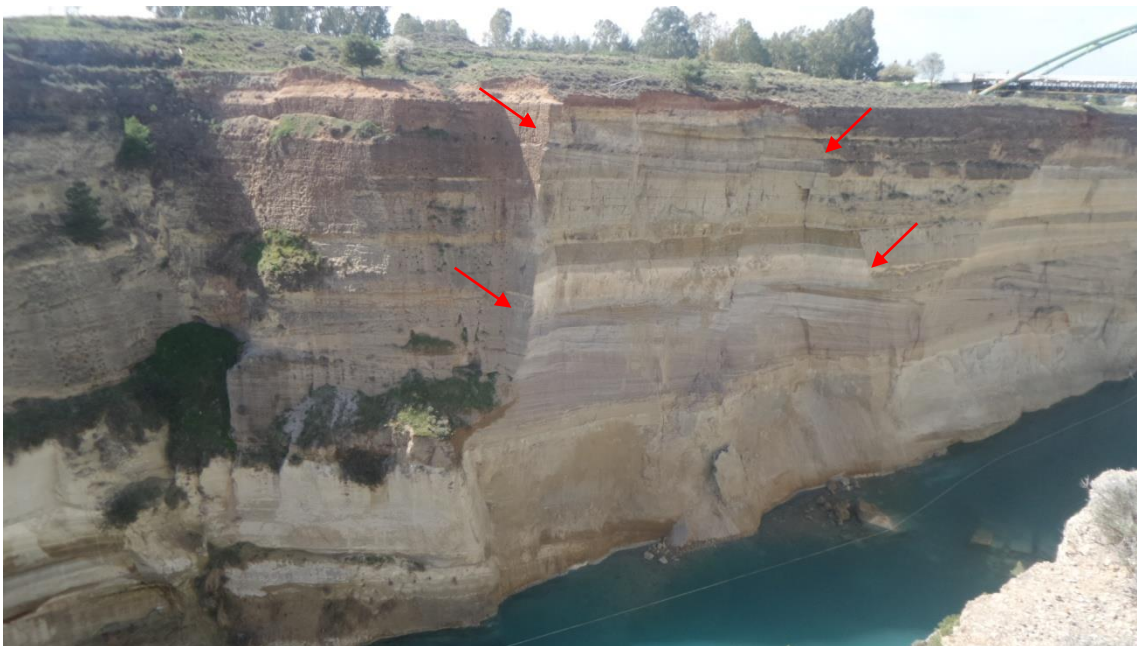
The risk of a large failure of the Canal slopes remains high, as demonstrated by the large failure that occurred on February 26 2018 and is shown in Figure 1. The safe operation of the canal may be endangered by the occurrence of slope failures and it is thus necessary to determine the risk from slope instabilities along the entire length of the canal and identify the higher risk areas. The use of new technologies, such as UAV-enabled mapping, in combination with field reconnaissance provides a very effective method of identifying the risk areas along the canal and calculating the slope stability conditions considering different loading scenarios, such as water pressure and seismic loading.

Figure 1. View of the slope failure, which occurred on February 26 2018 at the south slope of the Corinth Canal.

The 2018 failures occurred at the south slope at location 2500 m, an area belonging to Zone 4 per Andrikopoulou et al. 1988. The slope at this section has a slope angle of 80° and a total height of 45 m. The width of the affected zone by the first failure was approximately equal to 50 m and the height of the formed wedge was 45 m. As presented earlier, the slopes in this area are formed by marls and marly limestones with intercalations of sandstones.

The slope failure was due to the relaxation of the slope along the main joint, which intersects the fault present at that location. The failure may have been also triggered by rainfall, which occurred 3-4 days earlier. Based on the field survey, it was determined that the prism was detached along the joint which formed a tensile crack for the largest part of the slope (up to 40 m), while at the base, the failure occurred through the intact marl horizon. The slope geometry before the failure was not available and it was determined by extending the slope surface from the adjacent area to the failure. The volume of the failed block of the

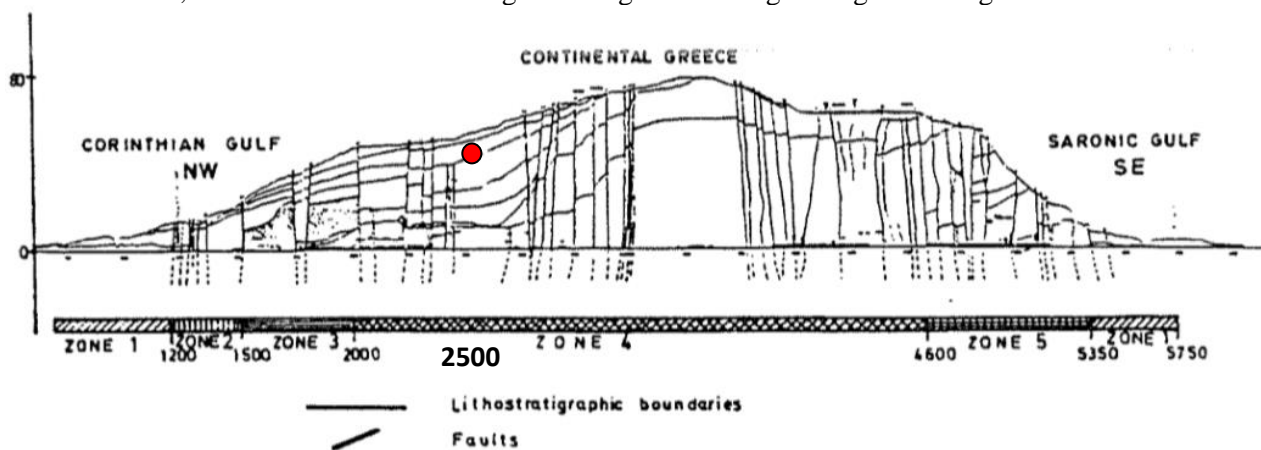
Figure 2. Geotechnical zoning of the Corinth Canal (from Andrikopoulou et al. 1988). The location of the slope failure is denoted.

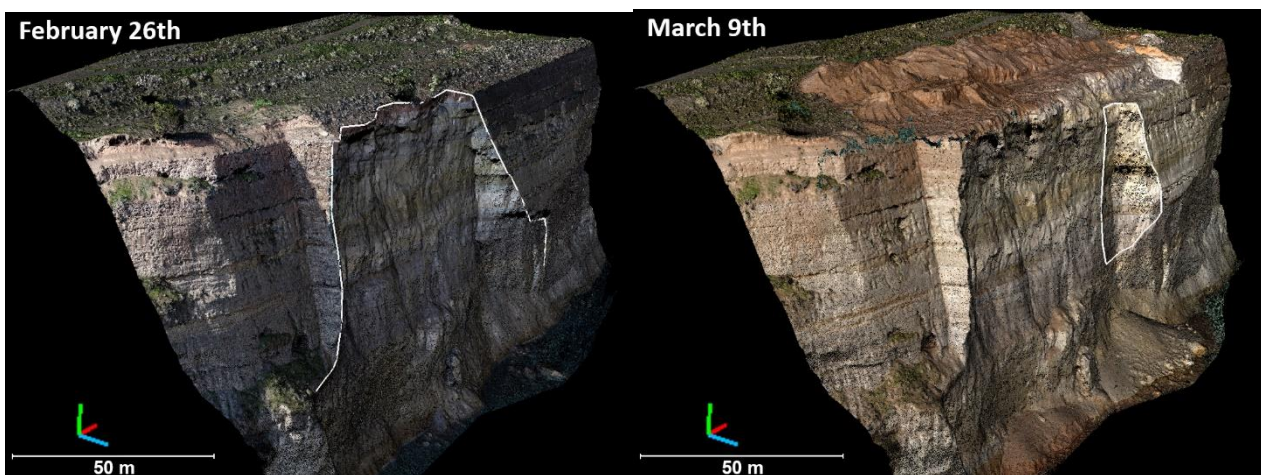
Figure 3. Point cloud of slope failure of Corinth Canal on February 26th and March 9th from Pix4D.

February 26th event, was calculated by differencing of the pre- and post-failure slope geometry in CloudCompare (GPL, 2015) and was determined equal to 6000 m³ (weight equal to 12000 tn). In order to analyze the kinematic stability of the wedge, it was necessary to determine the orientation of the planes controlling the failure.

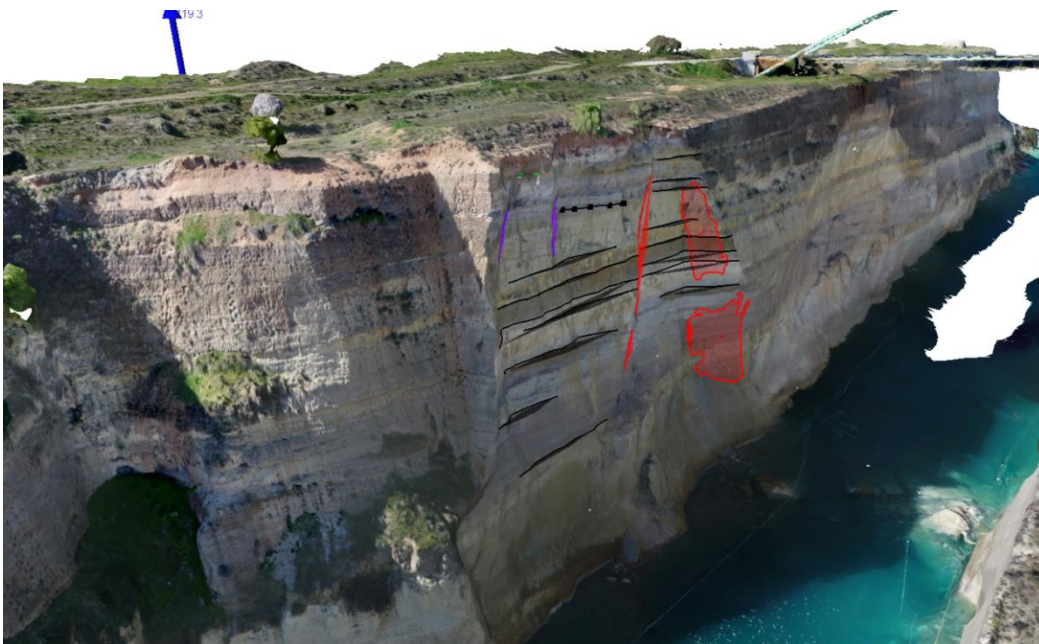
The geometry of the faults and main discontinuity sets were determined from the 3D photogrammetric models using photos captured from the UAV and the ShapeMetriX UAV (3GSM GmbH, Austria) software. Layers of marl and marly limestone were differentiated by mapping visibly different bands or beds of strata in three-dimensions. Similarly, other geological features, such as faults, joints and failure back scarps were also digitally mapped in 3D to identify the spatial location (X, Y and Z coordinates), the orientation of the planes (dip and dip direction), and the length or surface area of the planes. The identified discontinuities are presented in Figure 3. The Schmidt projection of the discontinuities is shown in Figure 4 and their mean orientations and geometrical characteristics are presented in Table 1.

Figure 3. 3D Model from ShapeMetriX UAV illustrating faults and main discontinuity surfaces controlling the slope failure of 26th February (fault surfaces in red, joint surfaces in blue, bedding surfaces in black).

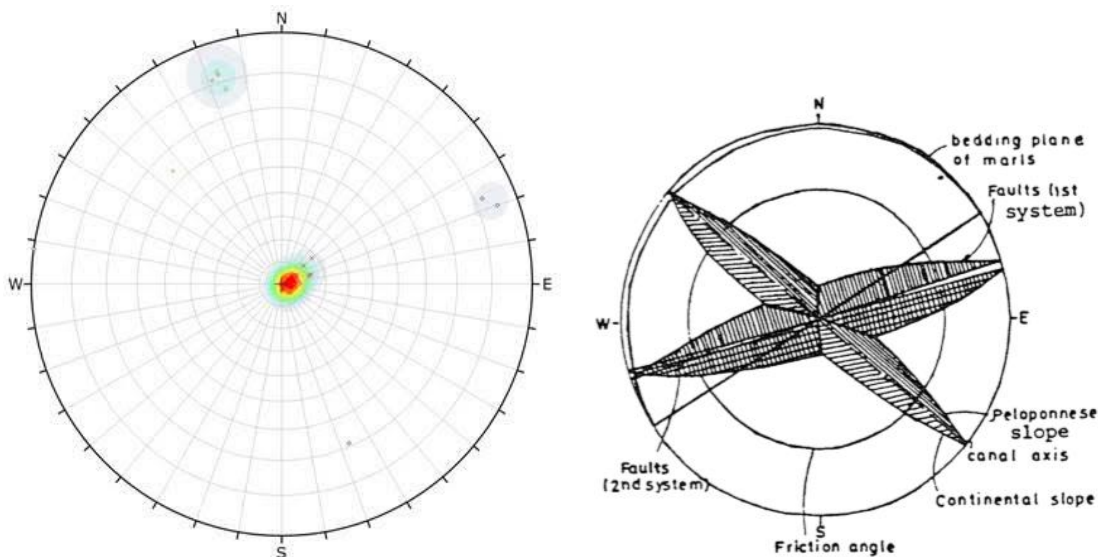
Figure 4. a) Lower hemisphere equal angle stereographic projection of main discontinuity surfaces controlling the slope failure. b) Structural data of the canal slopes (Andrikopoulou et al., 1988).

Table 1. Mean orientation and geometry of faults, bedding and discontinuity surfaces

Dip/Dip Direction	Length (m) (min-max)	Area (m ²)
<i>Fault</i>	71/149	18.2 – 22.9	
<i>Joint</i>	80/163	5.7 – 7.2	
<i>Backscarp</i>	70/290	-	23.7 – 120.1
<i>Bedding</i>	06/272	6.7 – 32.8

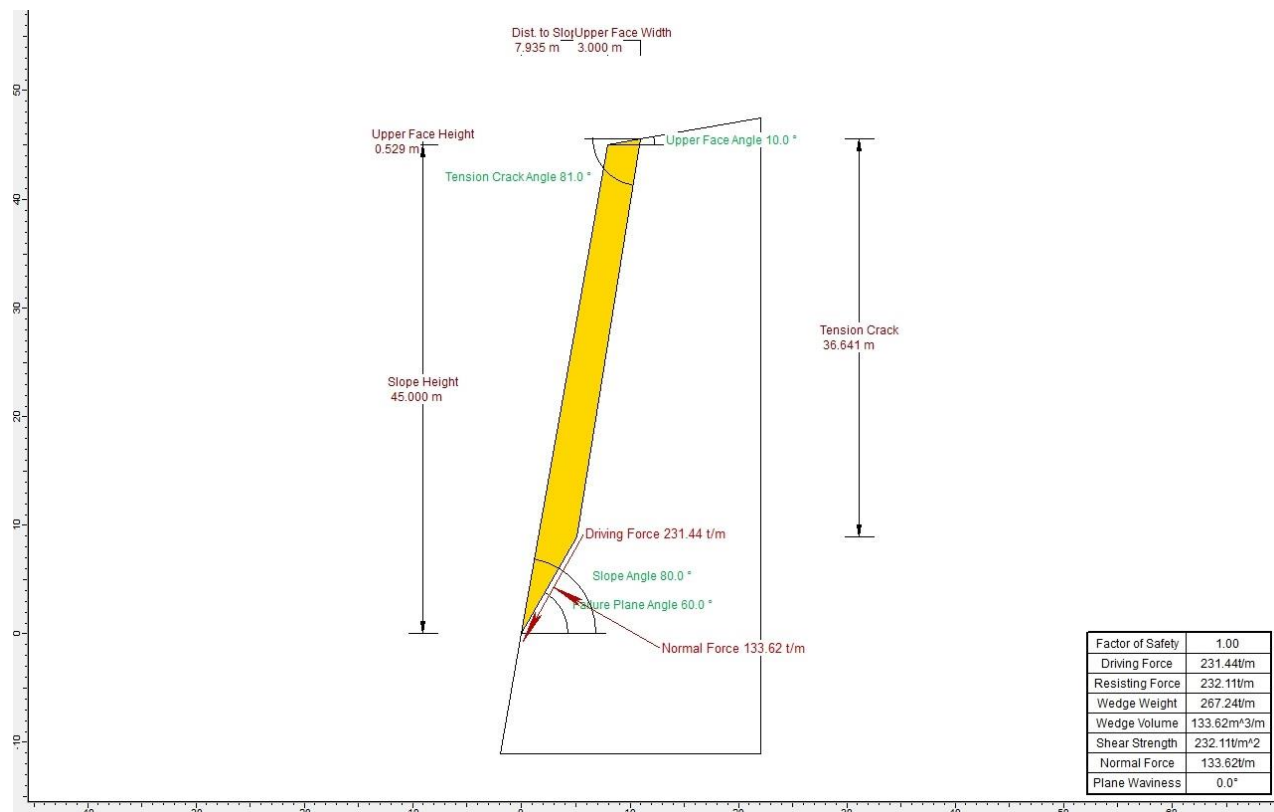
Based on the geometry of the main discontinuity forming the scarp, and considering the initial slope geometry, a back-analysis of the February 26 failure, was performed. The back-analysis was conducted considering a planar slide of a block at the base of the slope with failure through the intact marl and a tensile crack at the back scarp of the failure.

The total height of the failed block was 45 m and the distance of the tensile crack from the slope face was 3 m. The shear strength of the marl at the base of the failed block was determined equal to $c'=150$ kPa $\phi=35^0$ while no strength was attributed to the back scarp tensile surface. The factor of safety was calculated equal to 1.0. Based on the planar stability analysis shown in Figure 5, and for an assumed total unit weight of 2.0 tn/m^3 , the wedge weight of the block was 267 tn/m , resulting in a total weight of the failed block equal to 13350 tn . This agrees well with the weight determined by surface differencing of the pre- and post-failure slope geometry in Cloudcompare, which was 6000 m^3 (equivalent to 12000 tn).

Figure 5. Planar stability analysis of the failure of 26th February 2018 failure.

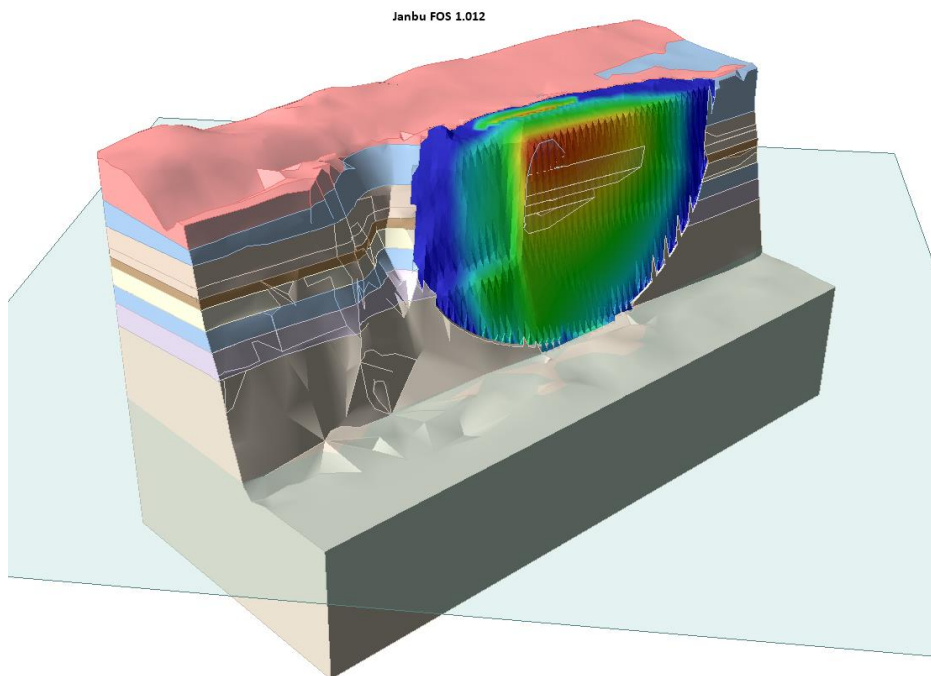
Three-dimensional limit equilibrium analysis (3D LEA) software, *Slide³ 2019* (Rocscience Inc.) was used to more accurately model the 3D nature of the 26th February 2018 slope failure. The ground model was developed based on key geological and geometrical features identified from photogrammetry as previously shown in Figure 3. Ellipsoidal slip surfaces were generated and assessed using various methods of columns calculation algorithms including Bishop, Janbu, Spencer and Morgenstern-Price (GLE). All resulted in similar slip surfaces and factors of safety very close to unity. The ellipsoidal slip surfaces were subsequently altered to find the lowest reasonable factor of safety. The shear strength of the marl at the base of the failed block was determined equal to $c'=150\text{kPa}$ and $\phi=35^\circ$, while the strength of the back scarp was equal to $c'=0\text{kPa}$ and $\phi=15^\circ$. The results of the back analysis are shown in Figure 6. The general nature of the slope failure was captured well in three-dimensions with the factor of safety in the model being 1.012 (i.e. close to failure). The 3D modeling approach, effectively identified failure surfaces very similar, from a geometrical perspective, to the actual event on February 26th 2018.

Figure 6. 3D slope stability limit equilibrium analysis results.
